ᐱᓕᓕᓕᓕᓕᓕᓕ
LAND FOR HOMES
IGLUQPIURVIKHAT

CLYDE RIVER NU

COMMUNITY SUMMARY

DRAFT January 2025

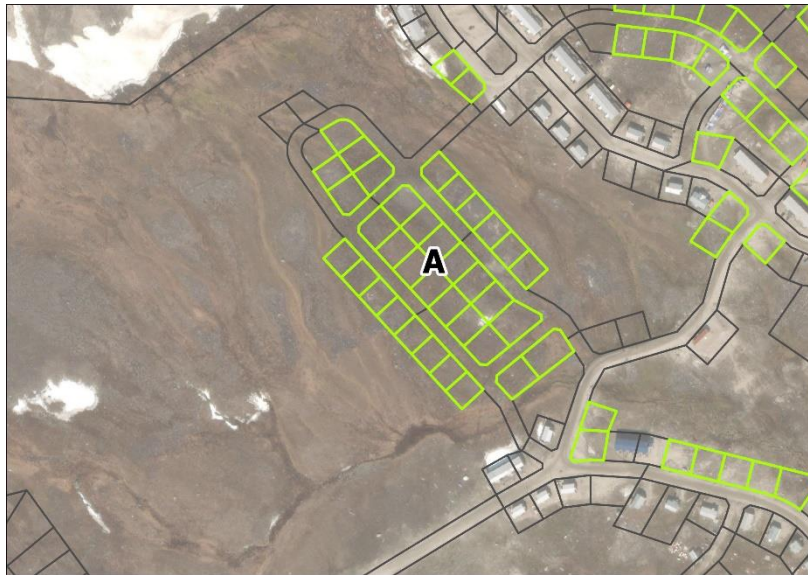
Figure 2: NEIGHBOUHOOD 'A' MAP

2023 NHC Tour: The intention of community to develop in this area should be confirmed. DSAO indicated drainage and permafrost concerns in this area. Some of the lots may not be suitable to build on as a result.

2024 L4H Desktop review: Approximately one third of the surveyed lots appear to be in zones identified as unsuitable to development. Watercourses about the neighbourhood on two sides which make for unfavorable building conditions on some lots

2024 L4H Tour: Potential drumlins present on parts of the neighborhood

2024 L4H Tour: Evidence of periodic flooding in parts of neighborhood, potential for permafrost degradation

2024 L4H Tour: Road infrastructure has not been extended to most of this neighbourhood. Roads will be needed to support construction in parts of the neighborhood

2024 L4H Tour: Partially complete. Drainage infrastructure has not been extended to most of this neighbourhood. Culvert at downstream end of watercourses when it meets existing road. Road cross culvert at road south of neighbourhood where watercourses meet existing road. No culverts or ditches observed in neighbourhood.

Infrastructure needed to mitigate soil and drainage conditions before housing construction can begin in parts of the neighbourhood.

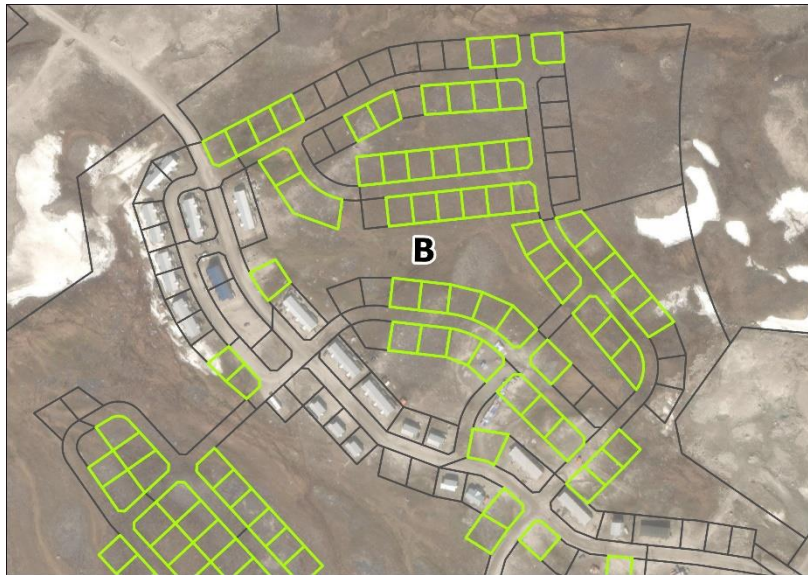
Figure 3: Neighbourhood B Map

2024 L4H Tour: noted that the neighbourhood exhibited poor soil conditions similar to that indicated by Hamlet staff.

"Mainly tundra intermixed with pockets of fractured rocks. Signs of potential sink holes that were filled with larger rocks. Further assessment may be required. Generally, sand/granular mix, some tundra. Appears stable in areas away from drainageways that pass through the neighbourhood."

2024 L4H Tour: Approximately one third of the surveyed lots appear to be in zones identified as unsuitable to development. Several drainageways cross neighbourhood. Municipal staff indicate several lots may not be suitable for development as a result. Understand neighbourhood will be resurveyed.

2024 L4H Tour: Potential for seasonal flooding due to drainage ways

2024 L4H Tour: Road infrastructure has not been extended to most of this neighbourhood. No road access to most of the remaining undeveloped lots in the neighbourhood. Access may be problematic to some due to soil conditions related to drainage.

2024 L4H Tour: Drainage infrastructure has not been extended to most of this neighbourhood. No ditches or culverts observed.
