### ARVIAT NU

COMMUNITY SUMMARY

DRAFT

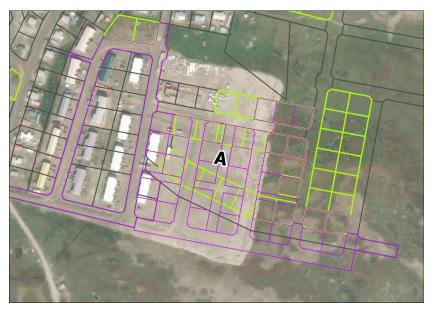
Figure 2: NEIGHBOUHOOD 'A' MAP (showing new plan of subdivision overlaid)

Soft, waterlogged tundra

2024 L4H Tour: Trip technical participants noted that, based on their observations, that the soil conditions in the new development are not suitable for housing. They recommended a detailed geotechnical investigation be completed before any further development is undertaken and significant drainage and dewatering work likely necessary.

Council noted concerns about the suitability of the surrounding lands, particularly with the new development in the east part of the hamlet (highlighted in image).

The Housing Association noted that the new 5-plexes built near the highlighted subdivision are already shifting due to the soil conditions.

2024 L4H Tour: Poor drainage, many ponds throughout neighbourhood. Particularly susceptible to excess runoff form snow melt.

New subdivision will be vulnerable and will require careful drainage design and consideration.

2024 L4H Tour: Technical members of team recommend development not take place until further drainage and geotechnical assessments can the completed to determine whether neighbourhood can be adequately dewatered.
