#### COMMUNITY EXECUTIVE SUMMARY

Rankin Inlet

# ΔレͻϲϷ<sup>ς</sup>διος LAND FOR HOMES IGLUQPIURVIKHAT

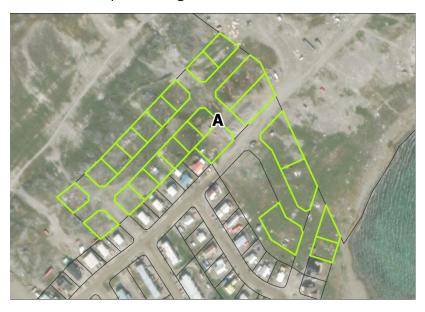
Figure 2: NEIGHBOUHOOD 'A' MAP

2024 L4H Tour: Newer lots proposed on outcrop. Rock outcrop along north and west edge of neighbourhood, which will be difficult to develop given the irregular topography. Large pond covering parts of planned road and Lots 5-7. Tundra with multiple ponded areas along NE corner of neighbourhood.

2024 L4H Tour: Sand/granular mix (depth unknown) abuts east and south side of outcrop. Tundra with multiple ponded areas along NE corner of neighbourhood. The lots planned for the north part of the community are located on a large rock outcrop, with pockets of lichen that backs onto the existing homes abutting these lots. These observations are consistent with a 2022 geotechnical and drainage report prepared by Nunami Stantec Ltd.

2024 L4H Tour: Drainage infrastructure have not been constructed in this area. No ditches or culverts observed. Infrastructure needed to address ponding within neighbourhood.

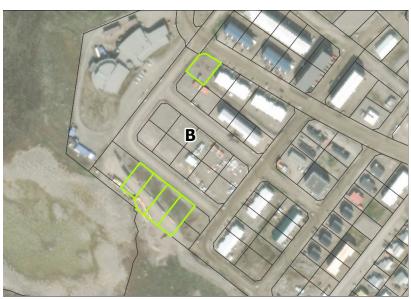
Figure 3: Neighbourhood B Map

2024 NHC Tour: Possible snow accumulation risk for this subdivision.

2024 NHC Tour: Road on lot 113-111 need to removed.
