ᐱᓕᓕᓕᓕᓕᓕᓕ
LAND FOR HOMES
IGLUQPIURVIKHAT

GJOA HAVEN NU

COMMUNITY SUMMARY

DRAFT January 2025

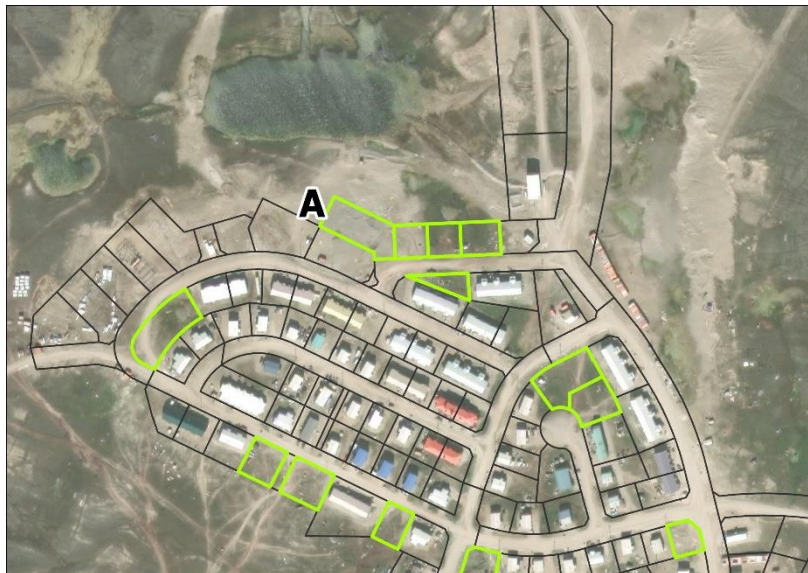
Figure 2: NEIGHBOUHOOD 'A' MAP

2023 Stantec Technical Report: On an elevated ridge sitting approximately 5 m above surrounding terrain.

2024 L4H Tour: Concerns regarding drainage and ponding issues

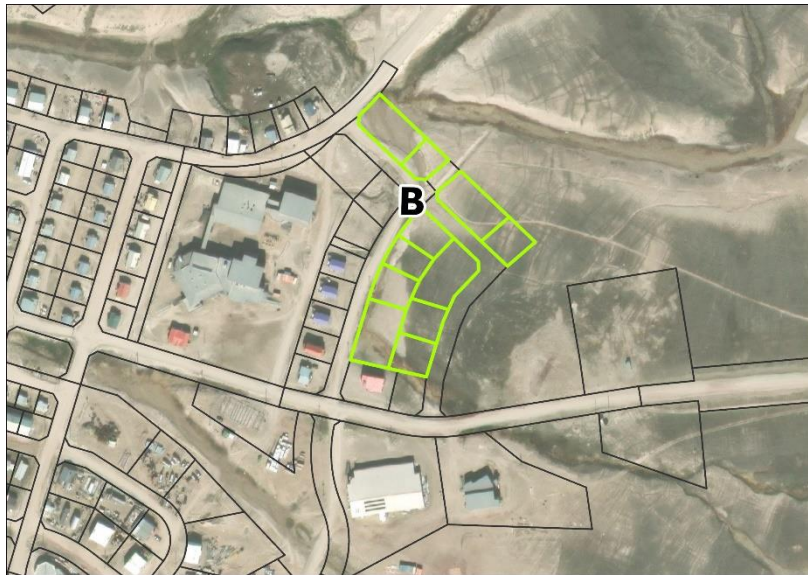
Figure 3: Neighbourhood B Map

2023 Stantec Technical Study: Many of east subdivision (Block 5 Plan 4589) surveyed lots deemed unsuitable for development due to drainage / slopes.

2024 L4H Tour: Sand, appear susceptible to erosion due to abutting drainage ways.

2024 L4H Tour: Two major drainage ways abut subject lot, consistent flow was observed. Neighborhood partially located within drainage corridor that separates Old and New Town

2023 Stantec Technical Study: The terrain in the area is mainly flat (< 5%), except for a short steep slope (~50%) present alongside a stream channel. The channel is showing signs of lateral erosion.

2024 L4H Tour: No culverts or ditches observed. Drainage way being maintained.
