ᐱᓄᓕᓃᓄᐱᓴᓴᓴ  
LAND FOR HOMES  
IGLUQPIURVIKHAT

# ARCTIC BAY NU

## COMMUNITY SUMMARY

DRAFT January 2025

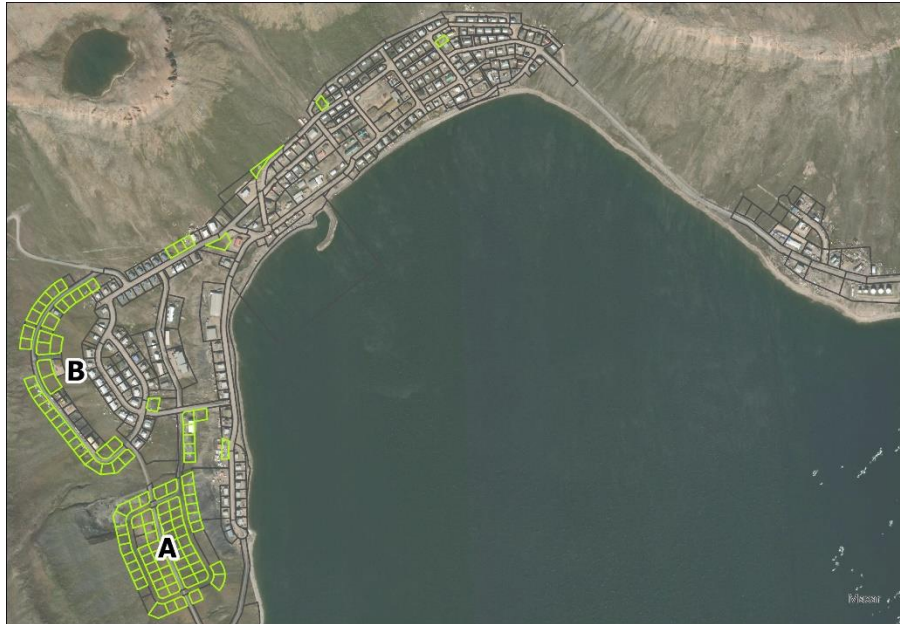
**Figure 1: COMMUNITY MAP**

Arctic Bay, known as Ikpiarjuk in Inuktitut, is the third most northerly community in Canada. As of the 2021 Census, the population is 995.

The community is surrounded by high hills and is vulnerable in places to rockslides and drainage from the mountains.

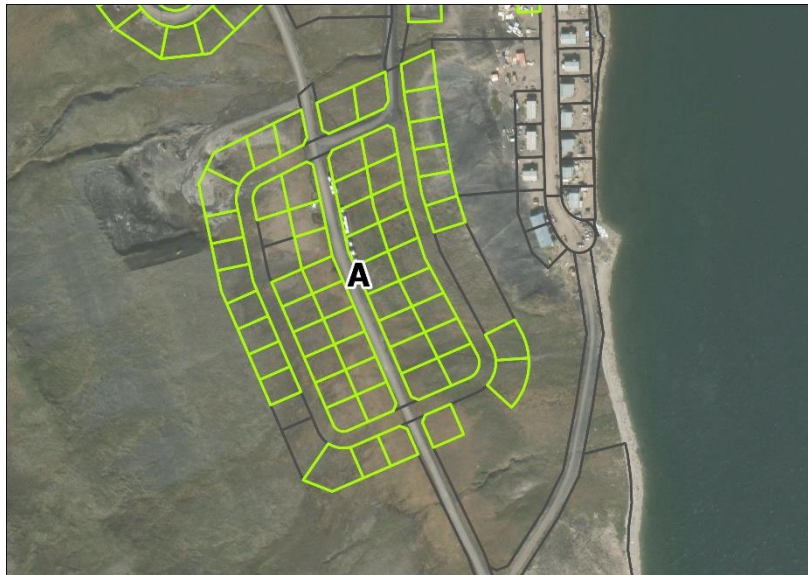
**Figure 2: NEIGHBOURHOOD 'A' MAP**

Block Number: 2

**General Description:** South Subdivision (Mitaviviningmiut)

2023 Stantec Technical Study: Two major gulleys run on either side of Block 2. Peak drainage discharge and shallow landslides initiating in or entering these gulleys may pose a hazard to local infrastructures (including roads, buildings and drainage structures). The soils in the southern portion of Block 2 appear to be poorly drained.

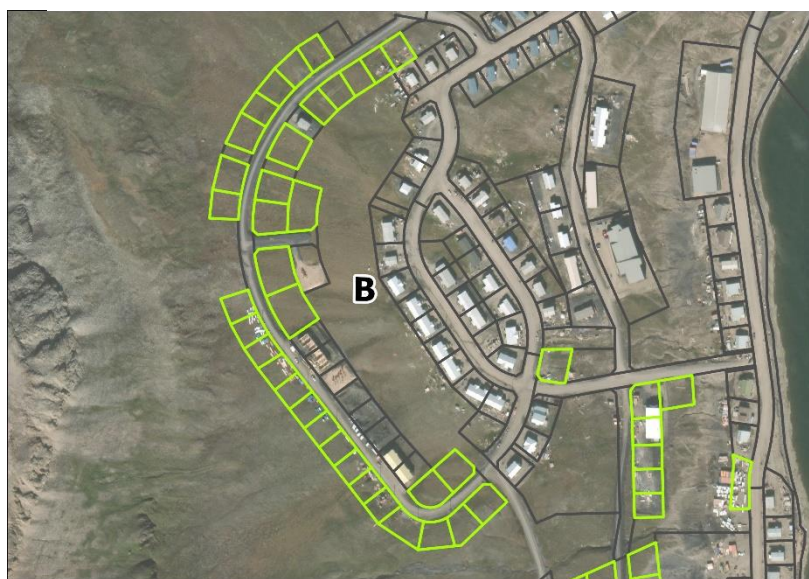
**Figure 3: Neighbourhood B Map**

**General Description:** Block 3 Plan 4090 (Qamanaugag)

2023 Stantec Technical Study: The uppermost portion of Block 3 was found to be located within 150 m of slopes segments presenting rockfall hazards. Evidence of landslides present along various slope segments surrounding the community, including upslope from Blocks 2, 3, and some are recent with potential impacts on existing infrastructure.
