## IGLOOLIK NU COMMUNITY SUMMARY

DRAFT

#### COMMUNITY EXECUTIVE SUMMARY

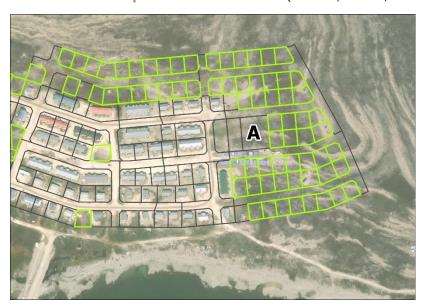
Figure 2: NEIGHBOUHOOD 'A' MAP

**General Description:** North East Area (Block 5,6and 7, Plan 4448)

2024 L4H Tour: Noted that land conditions are generally suitable for housing development provided adequate drainage measures are implemented, consistent with a 2020 geotechnical and drainage report prepared by Tera Tech.

2024 L4H Tour: Drainage appears acceptable, slopes towards shoreline which appears to promote positive drainage. No large drainageways observed.

2024 L4H Tour: No Road infrastructure Although no roads, soil conditions appears suitable for vehicle access given informal trails and roads observed.

2024 L4H Tour: No Drainage infrastructure, No culverts or ditches observed

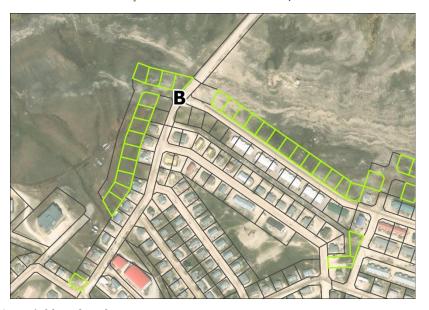
Figure 3: Neighbourhood B Map

**General Description:** North East Area (Block 3 and 4 Plan 4449)

Block 4 - Potential drainageway to north of neighbourhood. Ponding observed in neighbourhood.

2024 L4H Tour: Block 4 - Complete, Roads in Good Condition

2024 L4H Tour: Block 3 - No culverts or ditches observed. Infrastructure likely needed to address waterlogged soil conditions observed.

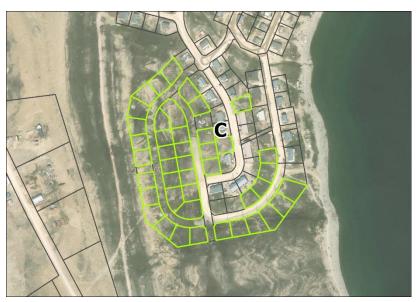
Figure 3: Neighbourhood C Map

General Description: South West Area (Block 2 Plan 3916)
